# Manhole Inspection Summary

Manhole # S35A\_\_002MH

Insp Date: **11/14/07 8:39 AM**

**Location** Address: **opp.649 st paul st**

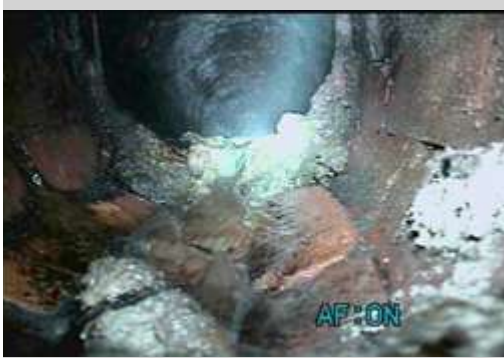
misc

channel debris

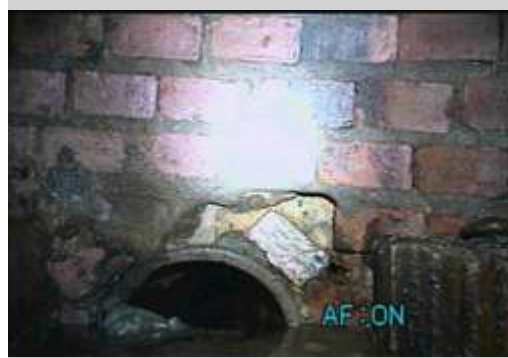
Defect 4

missing brick at 12

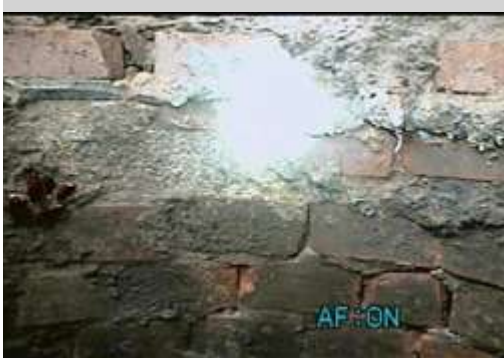
Defect 3

Condition: ☐ Sound ☐ Cracked ☐ Root Intrusion ☒ **Loose Brick** ☐ Deteriorated

chimney loose bricks

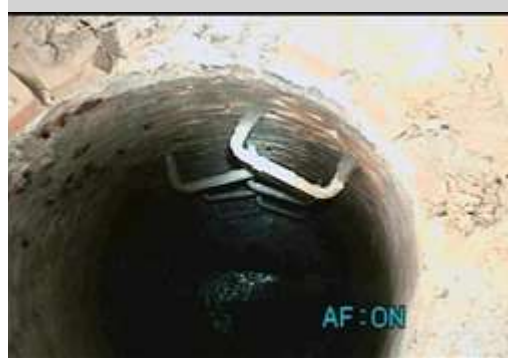
Defect 2

Count: **6** Missing: **0** ☒ **Corroded**

steps

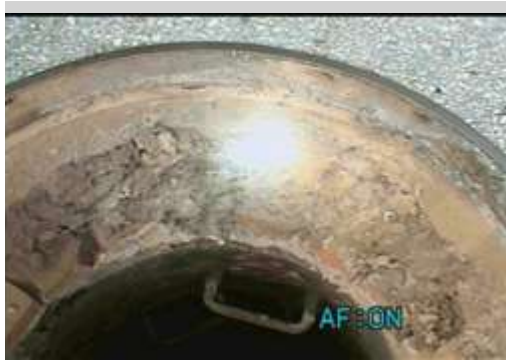
### Defect 1

Offset: **6** (in.)

frame offset
